HEALTH AND SAFETY REPORT

CLIENT	Cass hire and Sales	SAFETY ADVISOR	Nigel Kotula
SITE/DEPOT	Singleton Hospital, Swansea	DATE OF VISIT	23/09/2011
CONTACT		VISIT TYPE	Weekly inspection

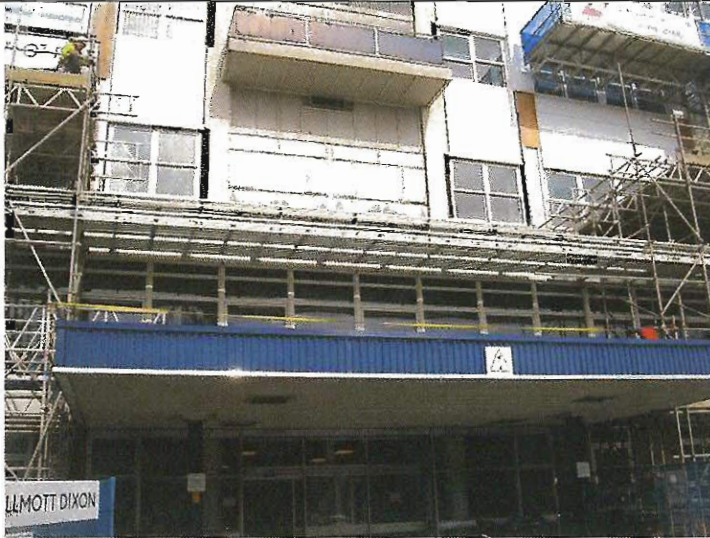
picture 3

Scaffold operatives were working in a safe and methodical manner at the time of my visit and fall prevention methods were being taken in the form of wearing and clipping on of harness sets whilst working at height.

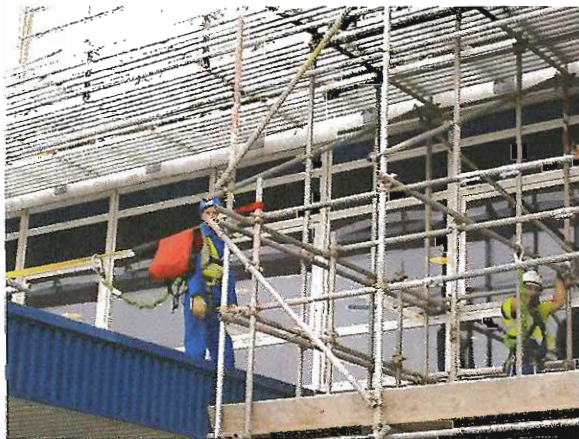
picture 4

Safety line fixed across canopy to allow scaffold operatives to attach harness to (picture 4) and clipped to scaffolding whilst working on lift (picture 5). All safety measures were being taken to reduce any risk of fall whilst working at height.

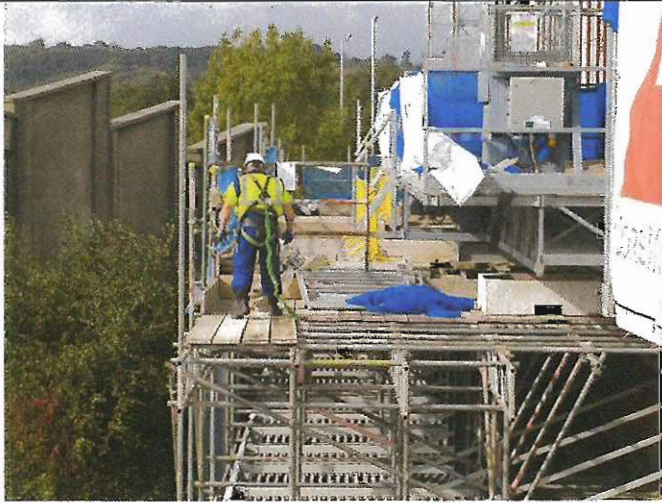
picture 5

Scaffolding had been erected to design SCD 1132-01. Copies of which are available in site files.

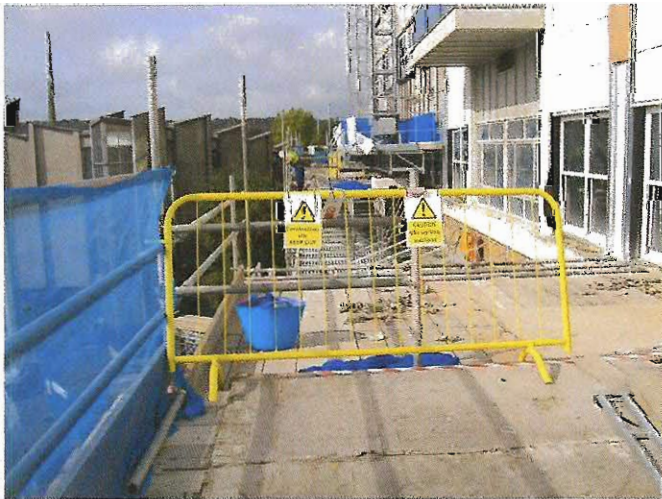
picture 6

Areas of work had been cordoned off to prevent any unauthorised access into unsafe area. Safety signage fixed.

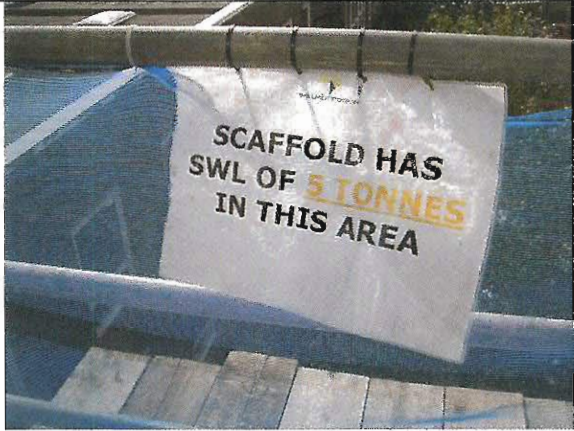
picture 7

Upon the scaffolding platform, safety signage has been placed to inform users where SWL applies.

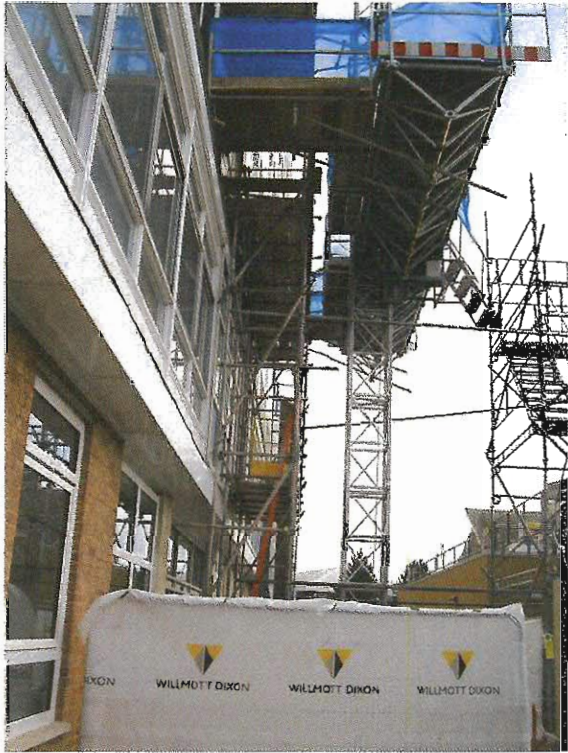
picture 8

One of the mast climbers has a haki stair tower erected for access onto cradle. This tower has been erected and tied back to inner independent. When cradle descends down the steps on cradle are adjacent to tower to allow safe access egress. (pictures 8 and 9)

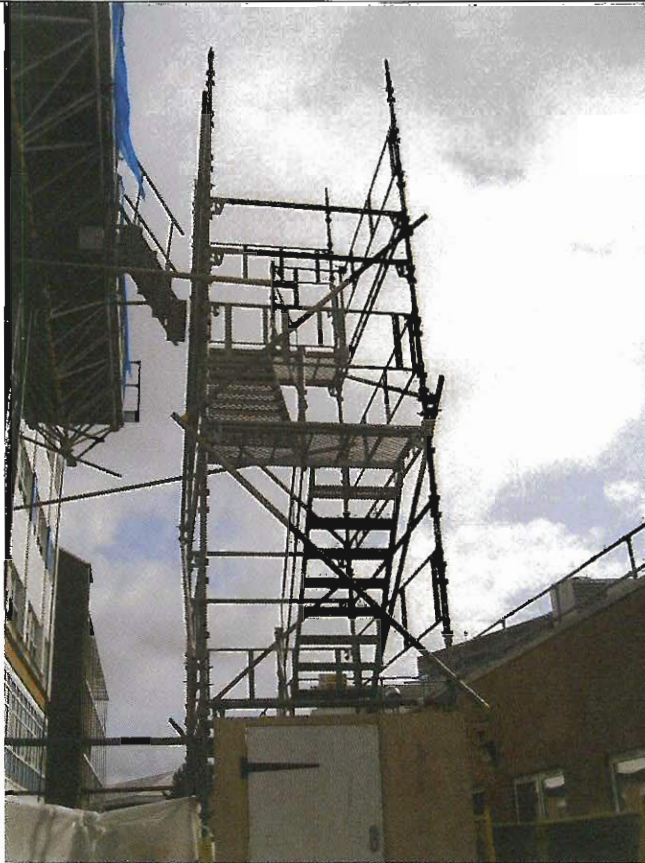
picture 9

Area at the base of the stair tower has been cordoned off by building a secure boarded area around tower. This has a combination lock on the door to prevent unauthorised entry.

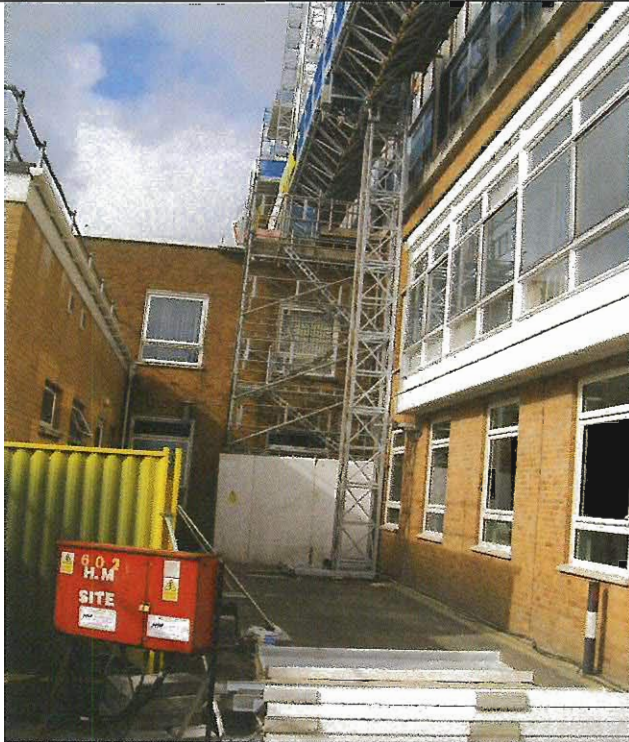
picture 10

The second stair tower has been erected with the same security at base and creates an access point to scaffold platform.

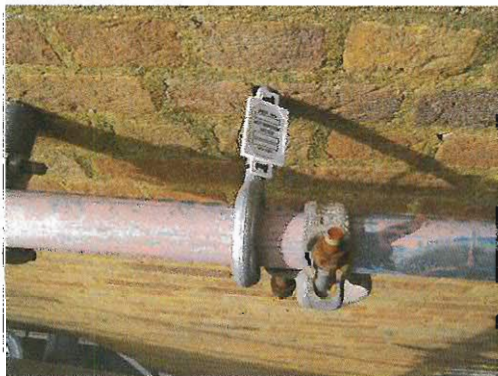
picture 11

All towers have been hilti tied with tags indicating test result and date of tie test.

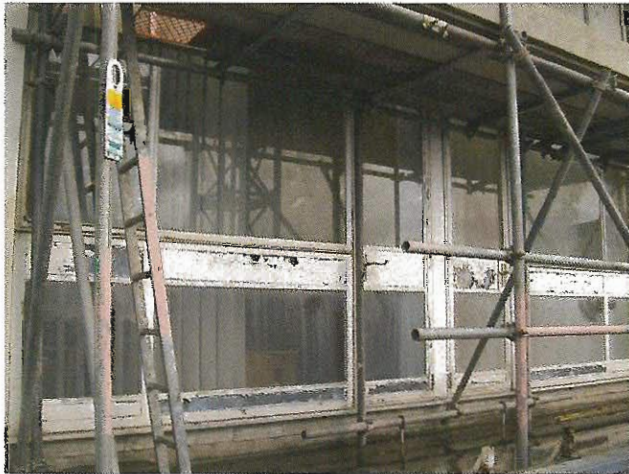
picture 12

Each tower has had a tag fitted and access points are through internal ladder with trap door protecting open access point.

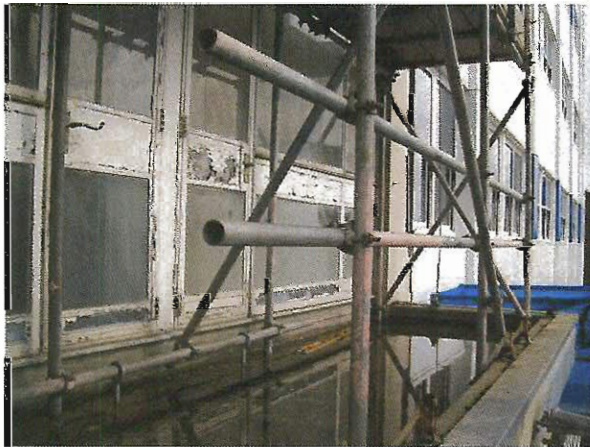
picture 13 – hilti ties at rear

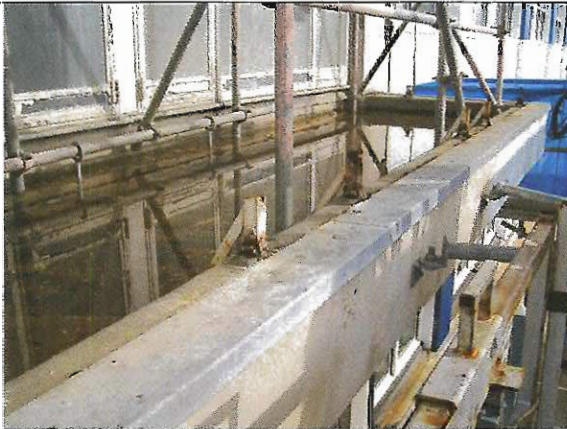
picture 14

Point of attachment for harness

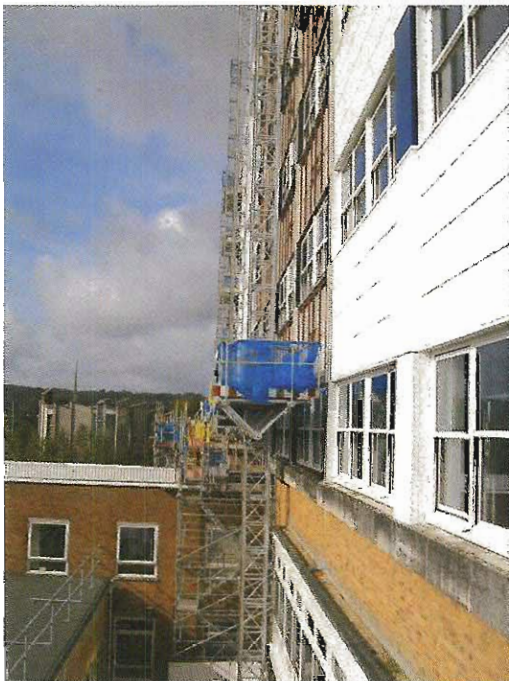
picture 15

View of mast climbers and access point.
